# Service visit report

| REPORT / WORK ORDER | TF-P312 | SITE / PROJECT | Sample commercial property |
| VISIT / START | 29 Sep 2026 / 11:10 | AREA / EQUIPMENT | Ground-floor kitchenette / Sink assembly P-03 |

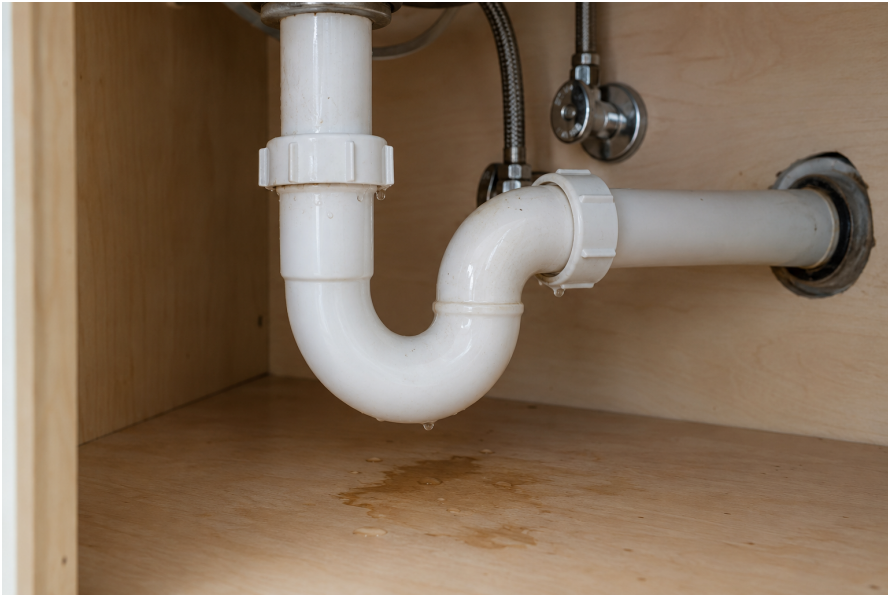
E01 / 00:48 / GENERATED PHOTO

| # | REPORT FIELD | RESPONSE / OBSERVATION | STATE | SOURCE |
|---|---|---|---|---|
| 2 | Visible condition | Moisture near under-sink connection | Needs attention | E01 |
| 3 | Cabinet base | Surface mark visible below pipework | Observed | E01 |
| 4 | Source of moisture | Further inspection required | Needs follow-up | N01 |

Connection and cabinet context

Visible droplets and a surface mark document the reported area. The image alone does not establish the leak source.

There are droplets at this connection and a mark on the cabinet base. I haven't confirmed the source yet. We need to check the joint and record a test after any repair.

| # | REPORT FIELD | RESPONSE / OBSERVATION | STATE | SOURCE |
|---|---|---|---|---|
| 6 | Next step | Inspect joint and record findings | Assigned | N01 |

| FOLLOW-UP ACTION | OWNER | WHEN / STATE |
|---|---|---|
| Inspect connection and confirm moisture source | Service technician | At follow-up / Open |
| Record repair and post-work test, if performed | Service technician | Before closing work / Open |
